**Flood Control Project Maintenance
Levee Inspections**

Maintenance Issue Types Only, Levee Inspection Report By Mile - Spring 2016

Reclamation District No. 0150 Merrit Island

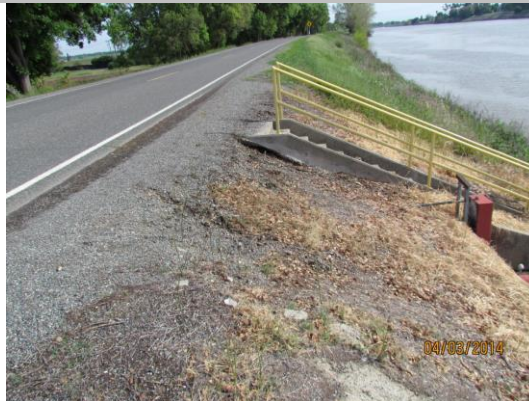
Photo 1 of 2 : SP_2016_RD0150_16_6_20160219_00002.jpg

LM Start	0.39	Rating **	M	Issue No.	6
LM End	0.39	Issue Type +	Ma	Location *	WS
Category	Earthen Levee			GPS Latitude/Longitude	
				Start	End
Item	Slope Stability			38.332717 °	38.332717 °
				-121.572083 °	-121.572083 °
DWR ID	DWR_RD0150_02_s_2012_6				
Comment Code					
S2 : Repair the levee slope damaged by foot traffic and prevent access where possible.					
Inspector Comment

Updated photo of the slope instability on the waterside of the levee looking upstream during spring 2014 inspection.

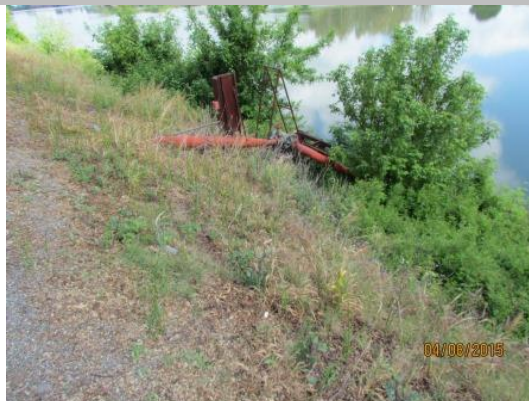
Photo 1 of 5 : SP_2016_RD0150_16_961_20160219_00047.jpg

LM Start	3.24	Rating **	M	Issue No.	961
LM End	3.24	Issue Type +	Ma	Location *	WS
Category	Earthen Levee			GPS Latitude/Longitude	
				Start	End
Item	Erosion / Bank Caving			38.355321 °	38.355321 °
				-121.530902 °	-121.530902 °
DWR ID	DWR_RD0150_02_s _ 2012_961				
Comment Code					
E2 : Schedule repair of erosion site prior to the next inspection.					
Inspector Comment					
Depressions into the waterward slope can be seen along the waterward slope at this site. Also note the damaged pump support, pump, and pipe just upstream of the site; they may contribute to the erosion in a high water event and should be removed.

Updated picture of the erosion on the waterside of the levee during spring 2015 inspection.

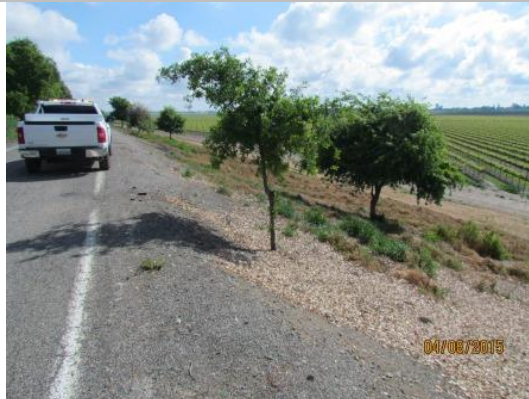
Photo 1 of 4 : SP_2016_RD0150_17_78_20160219_00071.jpg

Updated picture of the trees on the landside of the levee during spring 2015 inspection.

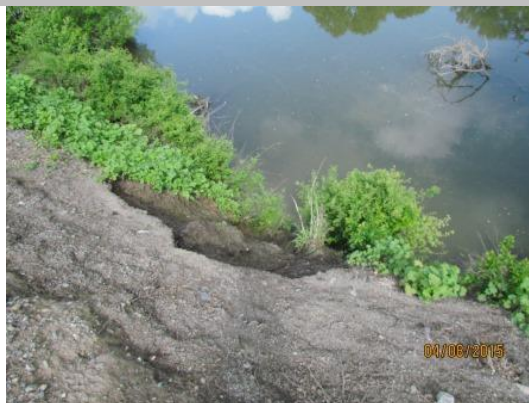
Photo 1 of 2 : SP_2016_RD0150_17_40_20160219_00033.jpg

Updated picture of the erosion on the waterside of the levee during spring 2015 inspection.

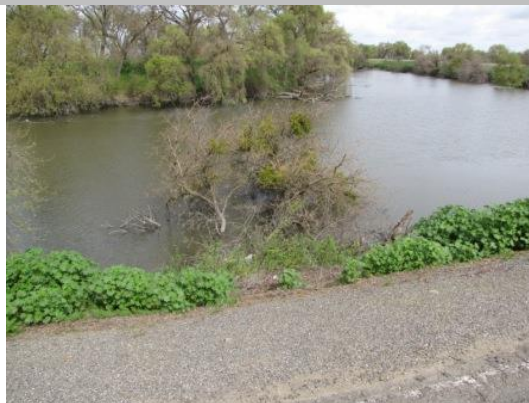
Photo 1 of 1 : SP_2016_RD0150_17_27_20160219_00020.jpg

LM Start	3.34	Rating **	N	Issue No.	27
LM End	3.34	Issue Type +	Ma	Location *	WS
Category	Earthen Levee			GPS Latitude/Longitude	
				Start	End
Item	Trim / Thin Trees			38.363147 °	38.363147 °
				-121.556190 °	-121.556190 °
DWR ID	DWR_RD0150_03_s_2012_27				
Comment Code					
T5 : Tree stumps.					
Inspector Comment

View of tree stumps on the waterside slope looking upstream.

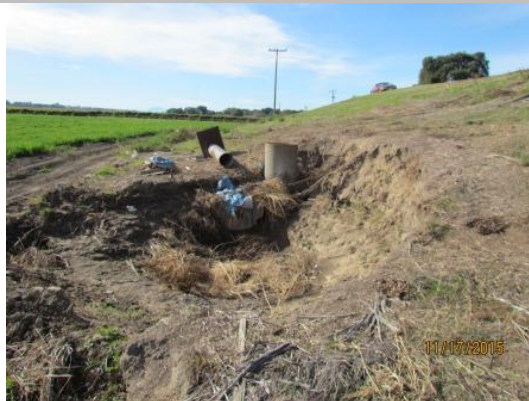
Photo 1 of 2 : SP_2016_RD0150_17_115_20160219_00088.jpg

Updated picture of the ditch on the landside toe of the levee during fall 2015 inspection.

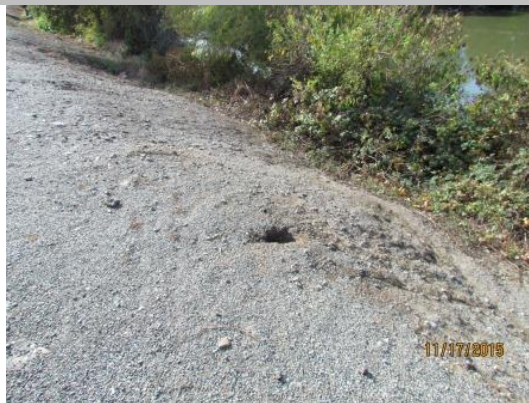
Photo 1 of 1 : SP_2016_RD0150_17_42_20160219_00035.jpg

LM Start	3.51	Rating **	M	Issue No.	42
LM End	3.51	Issue Type +	Ma	Location *	WS
Category	Earthen Levee			GPS Latitude/Longitude	
				Start	End
Item	Animal Control			38.365259 °	38.365259 °
				-121.555429 °	-121.555429 °
DWR ID	DWR_RD0150_03_f_2015_42				
Comment Code					
A3 : No rodents visible, but rodent burrows visible; need to backfill and compact or grout burrows.					
Inspector Comment

View of a rodent hole on the waterside of the levee.

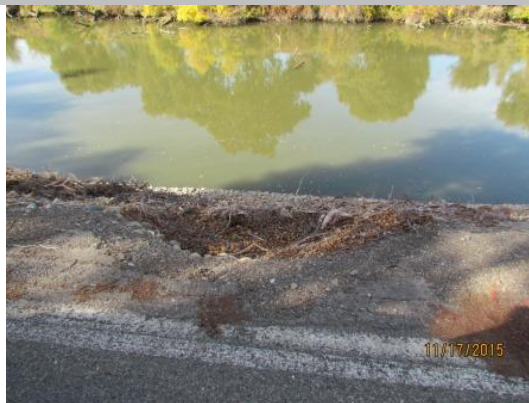
Photo 1 of 2 : SP_2016_RD0150_17_36_20160219_00030.jpg

Updated picture of the slope instability of the waterside shoulder of the levee during fall 2015 inspection.

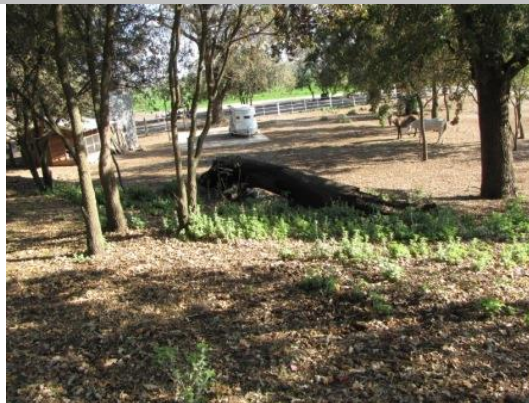
Photo 1 of 1 : SP_2016_RD0150_17_57_20160219_00053.jpg

LM Start	5.82	Rating **	M	Issue No.	57
LM End	5.82	Issue Type +	Ma	Location *	LS
Category	Earthen Levee			GPS Latitude/Longitude	
				Start	End
Item	Encroachments			38.384648 °	38.384648 °
				-121.540669 °	-121.540669 °
DWR ID	DWR_RD0150_03_s_2012_57				
Comment Code					
TR : Tree or limb					
Inspector Comment

View of a tree trunk lying on the landward slope blocking visibility.

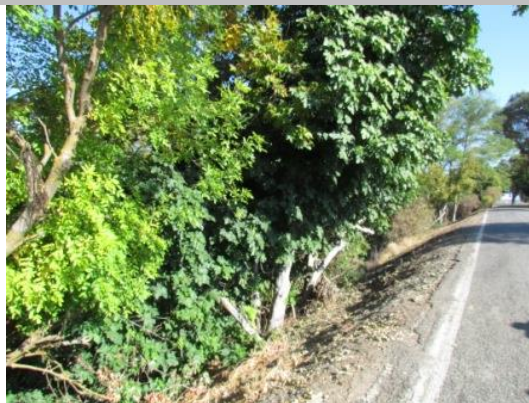
Photo 1 of 2 : SP_2016_RD0150_17_62_20160219_00059.jpg

Tree was blocking the visibility on the waterside of the levee looking upstream. This picture was taken during fall 2012 inspection.

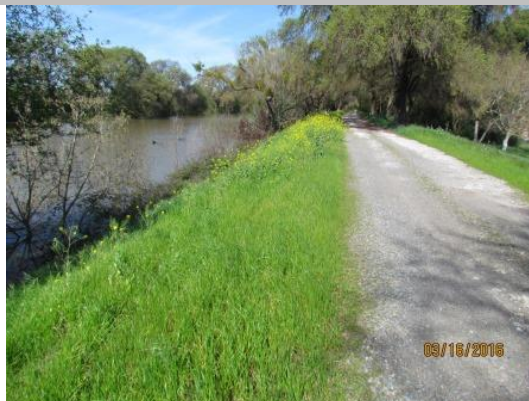
Photo 1 of 1 : SP_2016_RD0150_17_100_20160321_00152.jpg

LM Start	7.23	Rating **	M	Issue No.	100
LM End	9.32	Issue Type +	Ma	Location *	WS
Category	Earthen Levee			GPS Latitude/Longitude	
				Start	End
Item	Vegetation			38.401089 °	38.412987 °
				-121.536429 °	-121.524148 °
DWR ID	DWR_RD0150_03_s_2016_100				
Comment Code					
V1 : Control annual grass and weeds on the levee slopes and easements.					
Inspector Comment

View of the vegetation on the waterside slope of the levee looking upstream.

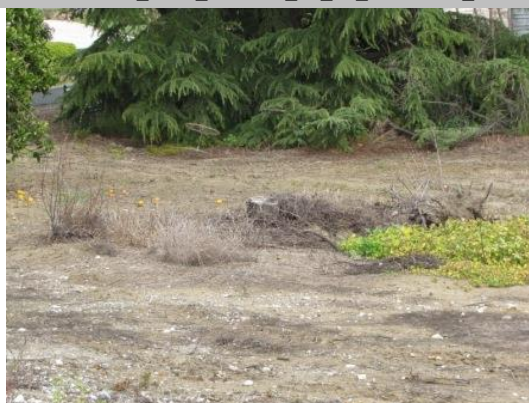
Photo 1 of 1 : SP_2016_RD0150_17_63_20160219_00061.jpg

LM Start	7.38	Rating **	N	Issue No.	63
LM End	7.38	Issue Type +	Ma	Location *	LS
Category	Earthen Levee			GPS Latitude/Longitude	
				Start	End
Item	Trim / Thin Trees			38.402779 °	38.402779 °
				-121.538197 °	-121.538197 °
DWR ID	DWR_RD0150_03_s_2012_63				
Comment Code					
T5 : Tree stumps.					
Inspector Comment

View of a tree stump on the landward slope.

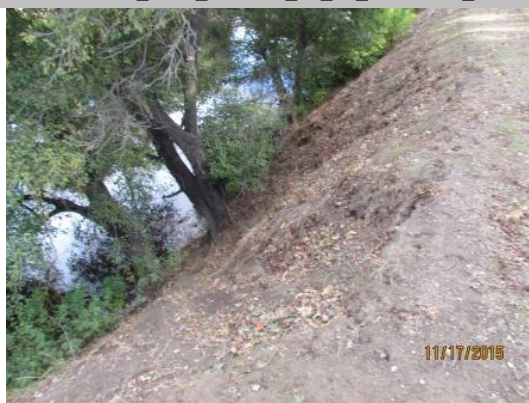
Photo 1 of 1 : SP_2016_RD0150_17_65_20160219_00063.jpg

LM Start	8.26	Rating **	M	Issue No.	65
LM End	8.26	Issue Type +	Ma	Location *	WS
Category	Earthen Levee			GPS Latitude/Longitude	
				Start	End
Item	Erosion / Bank Caving			38.408213 °	38.408213 °
				-121.535911 °	-121.535911 °
DWR ID	DWR_RD0150_03_f_2015_65				
Comment Code					
E1 : Note and monitor erosion site.					
Inspector Comment

View of erosion on the waterside of the levee.

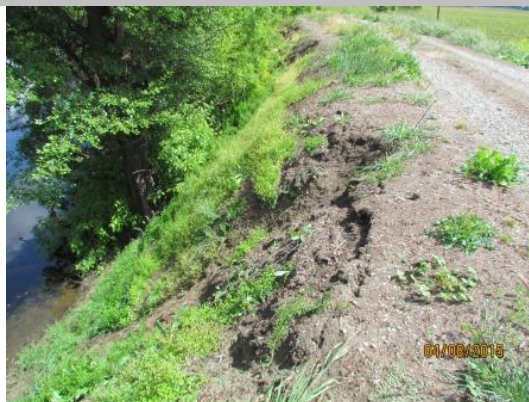
Photo 1 of 1 : SP_2016_RD0150_17_66_20160219_00064.jpg

LM Start	8.31	Rating **	M	Issue No.	66
LM End	8.31	Issue Type +	Ma	Location *	WS
Category	Earthen Levee			GPS Latitude/Longitude	
				Start	End
Item	Erosion / Bank Caving			38.407960 °	38.407960 °
				-121.534898 °	-121.534898 °
DWR ID	DWR_RD0150_03_s_2012_66				
Comment Code					
E1 : Note and monitor erosion site.					
Inspector Comment

Updated picture of the erosion on the waterside of the levee.

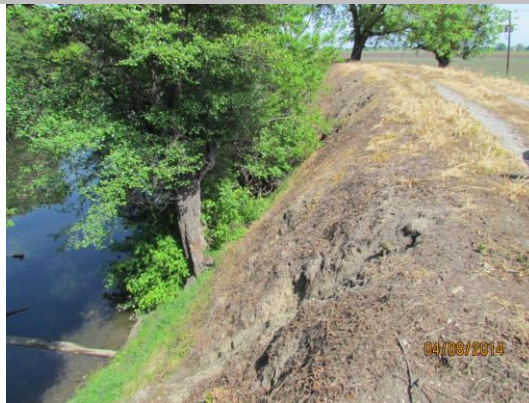
Photo 1 of 2 : SP_2016_RD0150_17_67_20160219_00065.jpg

Updated picture of the erosion on the waterside shoulder looking upstream during spring 2014 inspection.

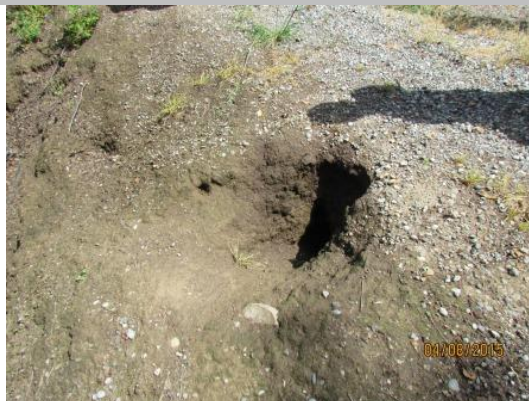
Photo 1 of 2 : SP_2016_RD0150_17_89_20160219_00081.jpg

LM Start	8.37	Rating **	U	Issue No.	89
LM End	8.37	Issue Type +	Ma	Location *	WS
Category	Earthen Levee			GPS Latitude/Longitude	
				Start	End
Item	Animal Control			38.408153 °	38.408153 °
				-121.533980 °	-121.533980 °
DWR ID	DWR_RD0150_03_s_2012_89				
Comment Code					
A1 : Exterminate rodents and backfill and compact or grout burrows.					
Inspector Comment

Updated picture of a rodent hole on the waterside shoulder of the levee during spring 2015 inspection.

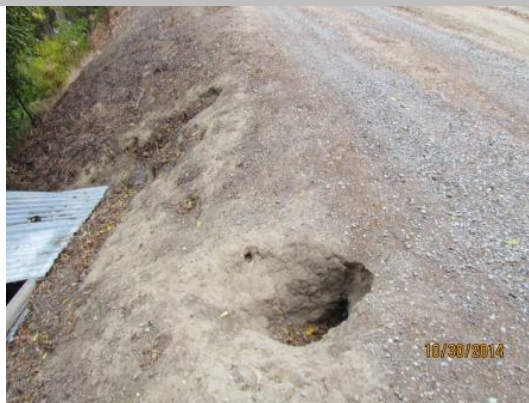
Photo 2 of 2 : SP_2016_RD0150_17_89_20160219_00082.jpg

Updated picture of a rodent hole on the waterside shoulder of the levee during fall 2014 inspection.
